Summary of Geomorphology Assessment Results

The geomorphic rapid assessment project is one part of a larger effort to update the Middle Huron River Watershed Management Plan (WMP). For this plan, HRWC employed an assessment method to evaluate the stability of representative stream reaches (i.e. segments) throughout the watershed. In summary, the rapid evaluation method assesses the erodibility of a stream reach's banks and the hydraulic forces impacting those banks to estimate erosion rates for each bank. These bank assessments can then be compiled into an overall erosion rate for the stream reach or average rates for all evaluated streams within a tributary creekshed. The erosion estimates individually should only be used to get a general sense of the scale of erosion relative to other streams in the system, rather than taken as precise estimates of sediment load, as the techniques are designed for a rapid and broad assessment.

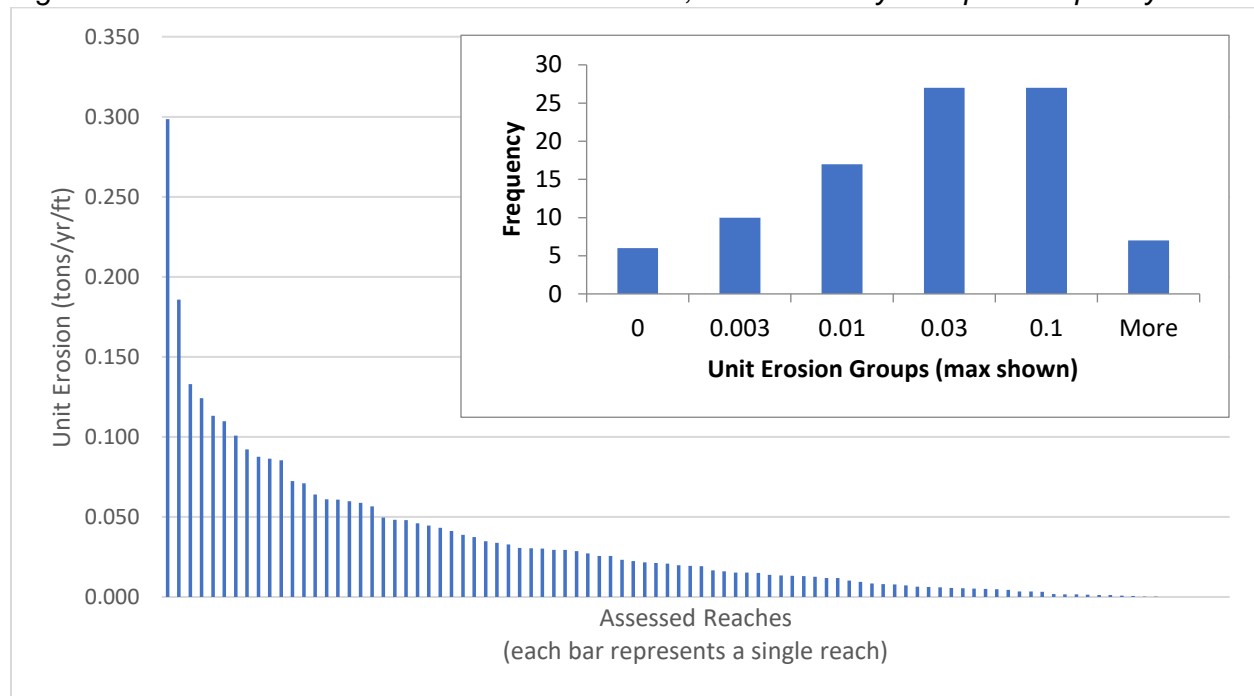
Figure 4. Estimated Unit Erosion Rates for Reaches, Overall and by Grouped Frequency

A second step in analysis is to compile assessment observations into mean erosion rates for entire reaches. Given the size of the study watershed and the total evaluated reach length, a comparative ranking of stream reaches is a good approach to identify initial restoration targets. Figure 3 shows the evaluated stream reaches and their erosion rates. Within the watershed, there are a small number (7) of stream reaches with high erosion rates (> 0.1 and < 0.30 tons/yr/ft, marked red). The majority of streams (54 of 94 evaluated reaches) fall within a moderate erosion rate range of 0.01 to 0.099 tons/yr/ft, marked yellow. The remaining reaches (24%) have stable banks with little evidence of active erosion (< 0.01 tons/yr/ft), marked purple.

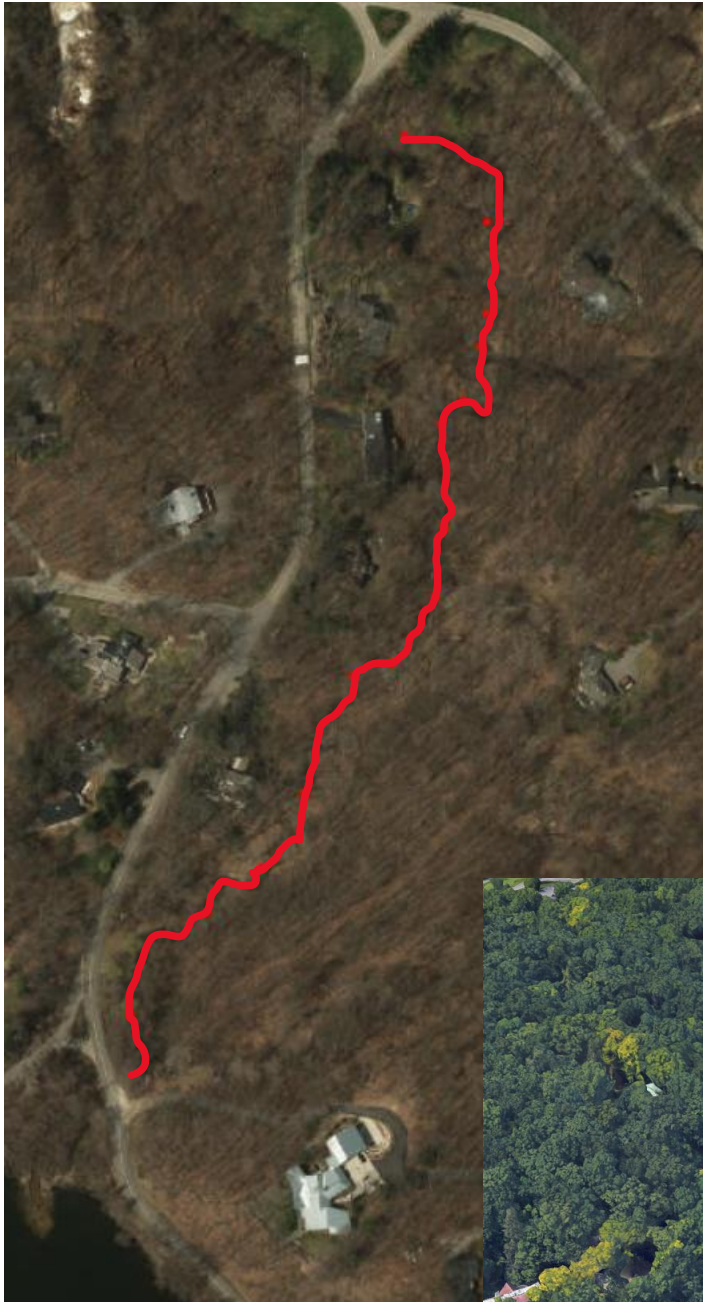
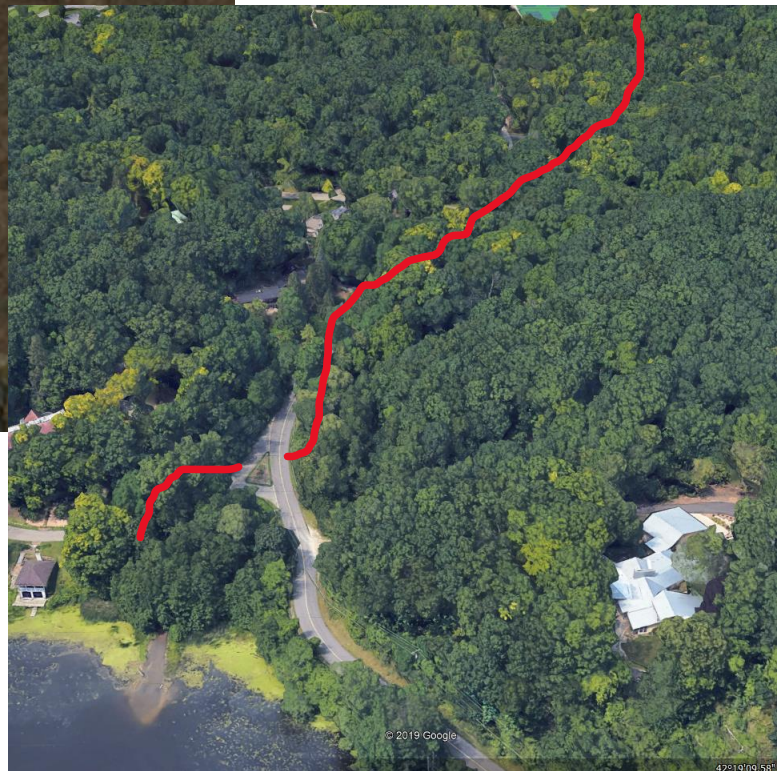
55 – Direct Drainage in Barton Hills

The hill slopes in Barton Hills are very steep for this part of the watershed. Past erosion is evident in the deposition into Barton Pond at the creek outlet. The stream channel has numerous high, exposed banks with little vegetation to anchor it. The entire reach was evaluated to have high erosion potential.

The unnamed stream that includes reach #55 runs entirely through the private residential establishment of Barton Hills Village. The Village expressed support for restoration work and could be a funding partner.

Given the slopes and unusual (to the rest of the Middle Huron River Watershed, at least) substrate (more larger material), detailed survey work should be completed to confirm active erosion, prior to designing solutions.

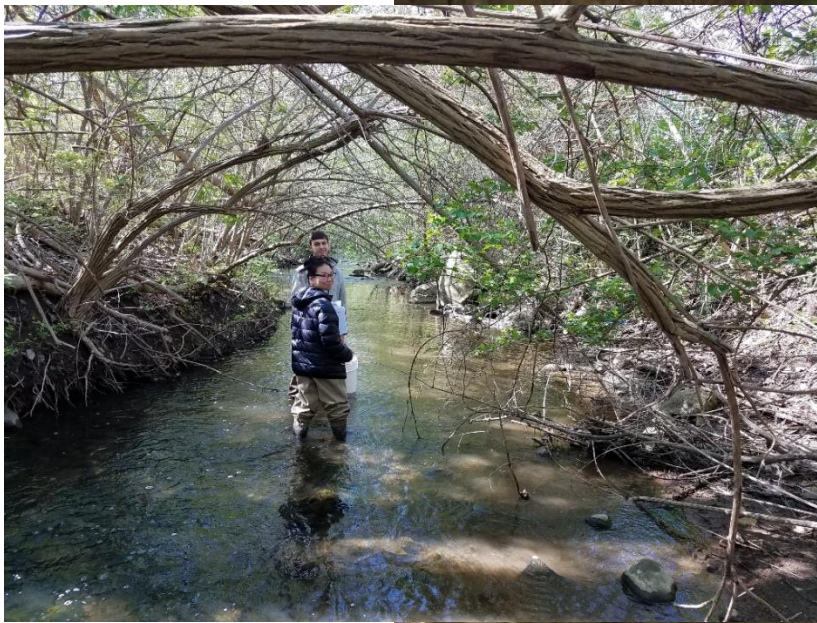
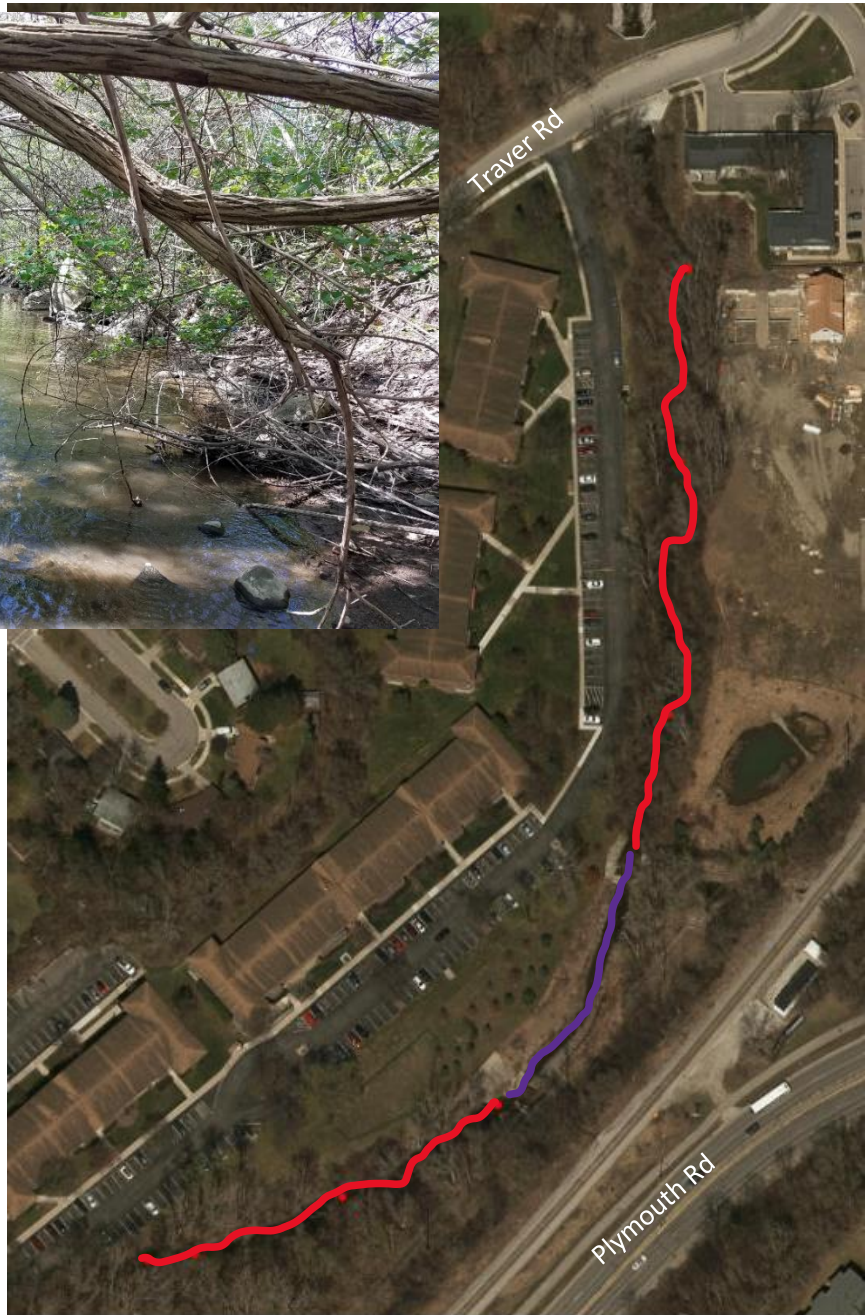
669 – Traver Creek

Reach #669 is in the middle section of the Traver Creek watershed, downstream of a small impoundment in Leslie Park Golf Course. Two sections of this reach have been highly impacted by previously altered flows and development of impervious surfaces within the creeks floodplain. A middle section with a better connection to the floodplain exhibits low erosion potential.

The upper section will be difficult to reconnect to its floodplain, of which little is remaining. It is likely that only streambank stabilization will be available in this section.

There is more available room in the lower section of the reach. This section follows an already stable section, with less encroachment into the floodplain. A wider range of restoration techniques could be utilized here. However, the adjoining property is privately held and would need to be purchased to allow for proper restoration.

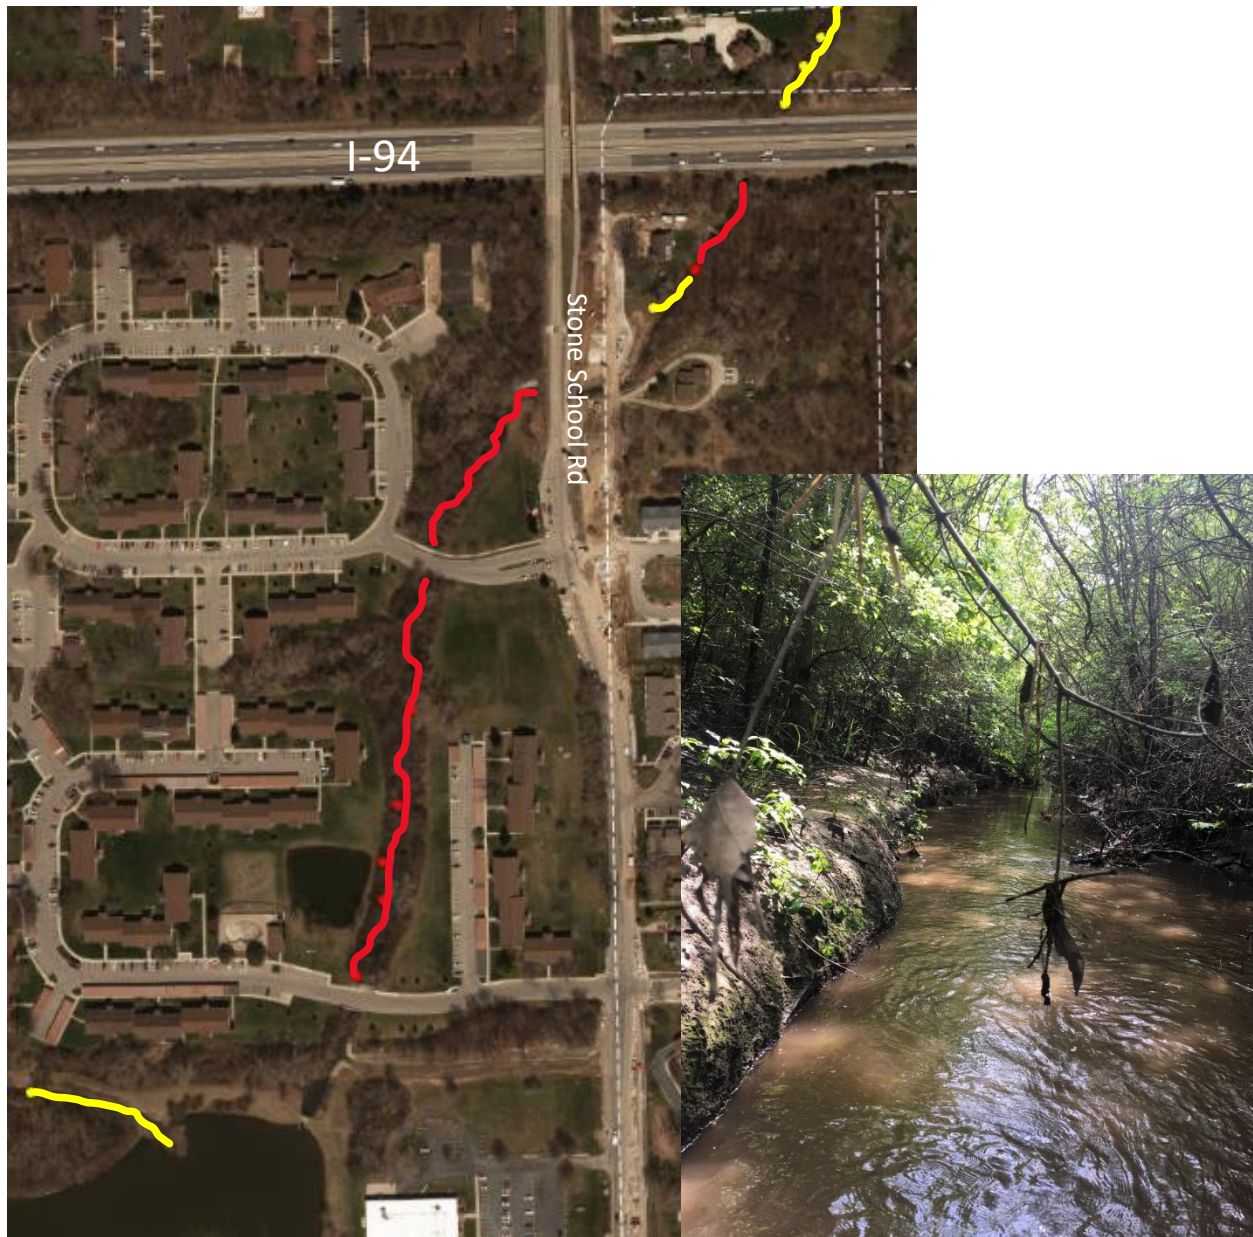
173 – Malletts Creek

This somewhat longer reach (1,859 linear feet in length) in Malletts Creek (#173) suffers from some of the similar impacts as #669 previously. It also is downstream of an impoundment that may control flows somewhat. However, extensive urban development through the creek's floodplain has left little connection available. The middle section down to Stone School Road likely only would allow streambank stabilization to protect from further erosion.

In the lower section of the reach, there is some evidence that the conveyance under Interstate 94 is undersized, as there is evidence of impoundment (and accompanying deposition), and more modest evidence of scouring on the downstream side of the highway. The culvert under Stone School Road should likewise be evaluated. Between these two crossings, there is room for restoration, though the reach section is quite short.

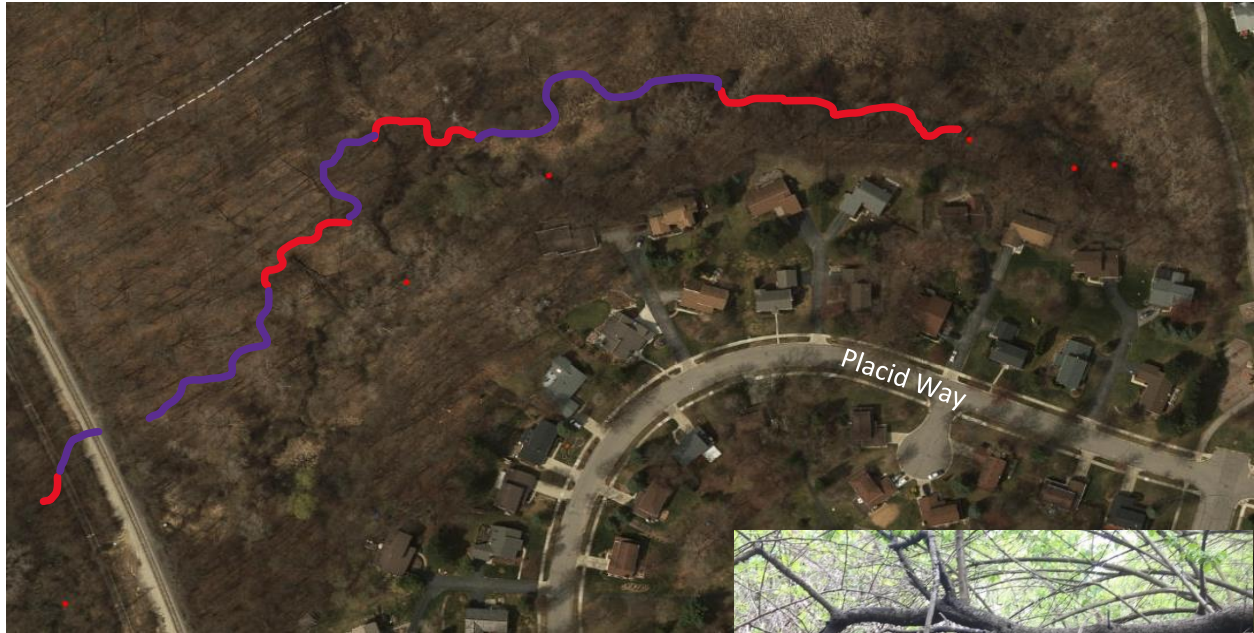
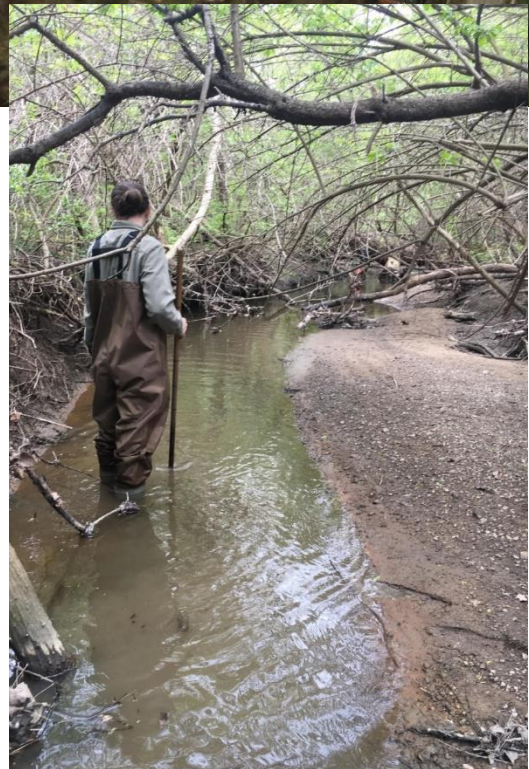
674 – Traver Creek

Reach #674, the second eroding reach identified in the Traver Creek watershed stands out as unusual among the other target reaches. It seems to present ample opportunity for restoration. The reach lies between confluences at the upper and lower ends. Erosion of alternating banks is evident along three sections with intermittent stable sections of very low erosion in between. There is ample available floodplain to work with, allowing for a variety of restoration techniques. The relatively small creek size, lighter development upstream, and existing sinuosity of the reach suggest good prospects for stable restoration. The north side of the creek borders a city-owned public park which should allow for a willing partner and access. Access to existing roadway may be a bit distant, however.

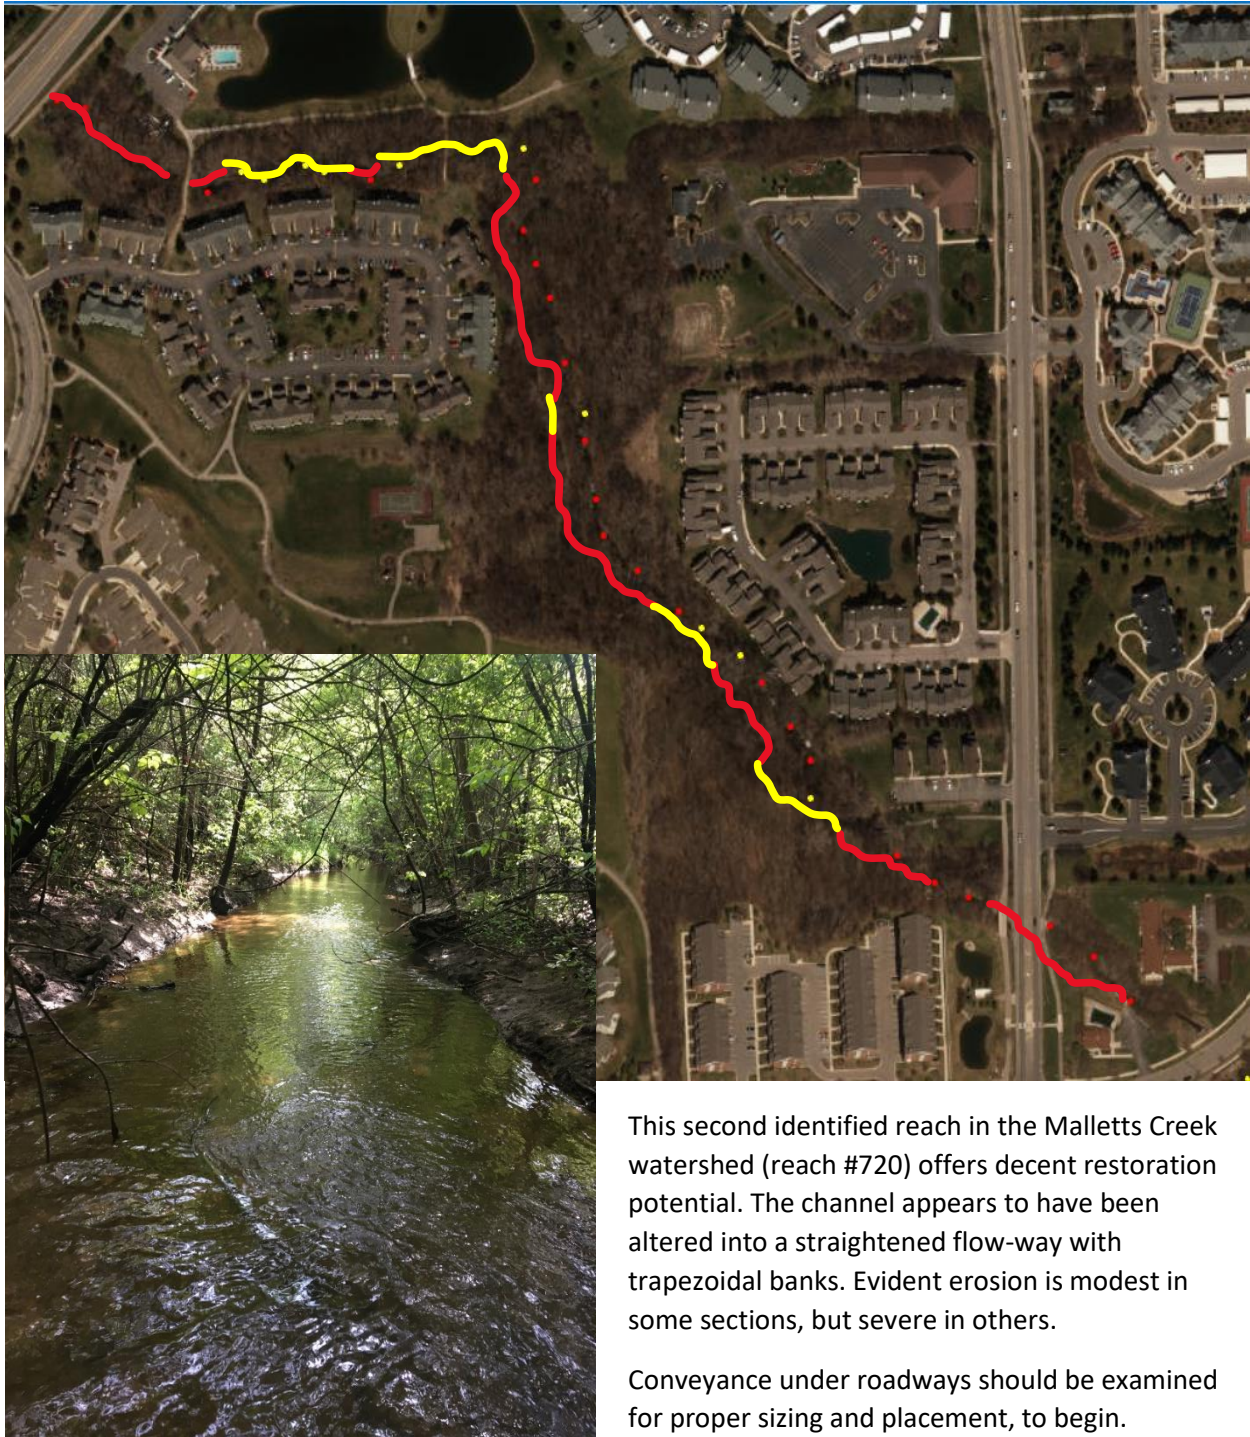
720 – Malletts Creek

This second identified reach in the Malletts Creek watershed (reach #720) offers decent restoration potential. The channel appears to have been altered into a straightened flow-way with trapezoidal banks. Evident erosion is modest in some sections, but severe in others.

Conveyance under roadways should be examined for proper sizing and placement, to begin.

Otherwise, the riparian cover along most of the stream reach is good, with ample space to reconnect the floodplain, or at least to reduce bank angles. This section is a county drain, with easements available for access and work. Additional property may need to be obtained, if floodplain connection is deemed feasible. Upstream flows should be evaluated to ensure proper restoration sizing.

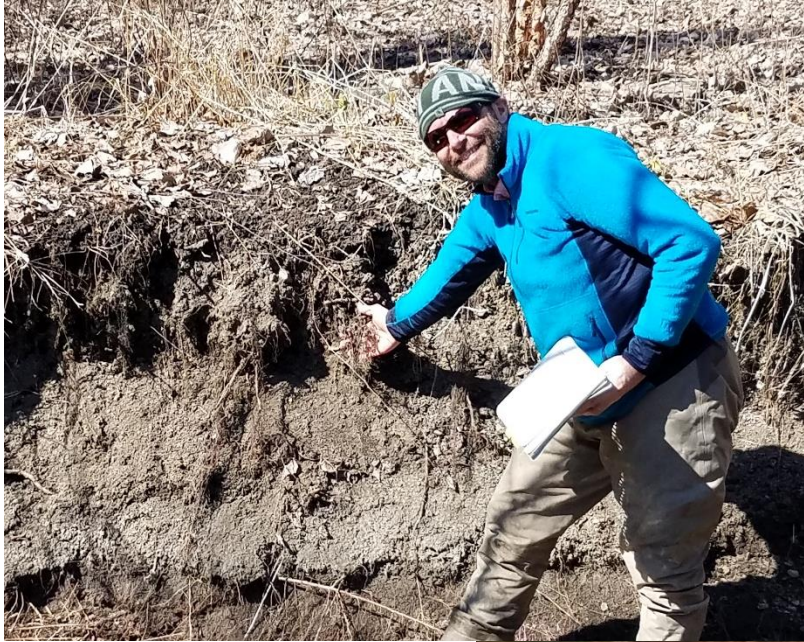
725 – Swift Run

The final target reach (#725) is a long (7,181 linear feet) section of Swift Run. While the upper section of the creek upstream of the U.S. 23 highway crossing exhibits relatively modest evidence of active erosion, the downstream section has long stretches of quite significant erosion.

Two sections should be further evaluated for potential restoration. The first section runs through property owned by Washtenaw County in Pittsfield Township. The floodplain here is tightly contained between development, so likely

would only allow for bank stabilization techniques. Downstream of the Clark Road crossing the development is more modest, with good riparian cover. Disconnection from the floodplain is significant, though, so restoration would likely require significant excavation and manipulation. Land ownership is mixed, but would likely be supportive of restoration.
