5 Chilson Creek at Chilson Road

Adopt-a-Stream Site Report

— Updated July 2021 —

Chilson Creekshed

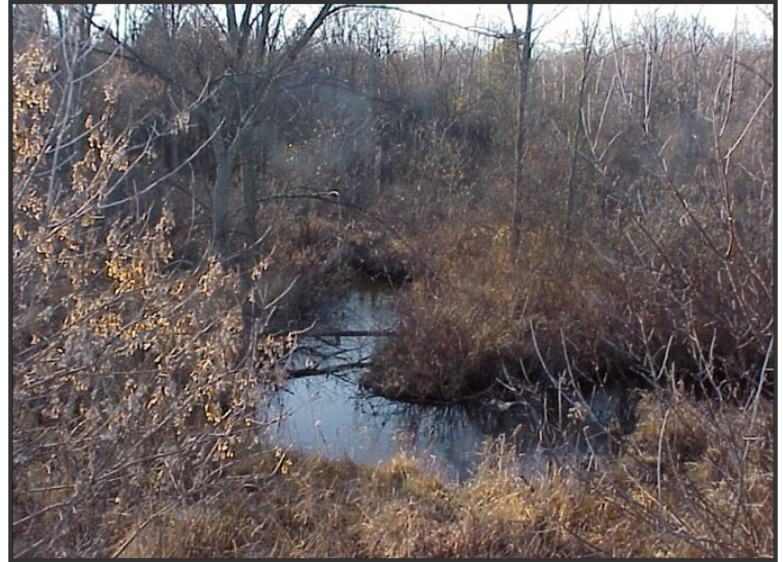
Site Condition: **GOOD**

In terms of overall water and habitat quality, this site has above average when compared to streams across the Huron River Watershed. The water is clean and cool and the stream banks, streambed, and streamside vegetation are healthy. However, the sensitive insects are declining, like many locations in Livingston County, as urban sprawl continues.

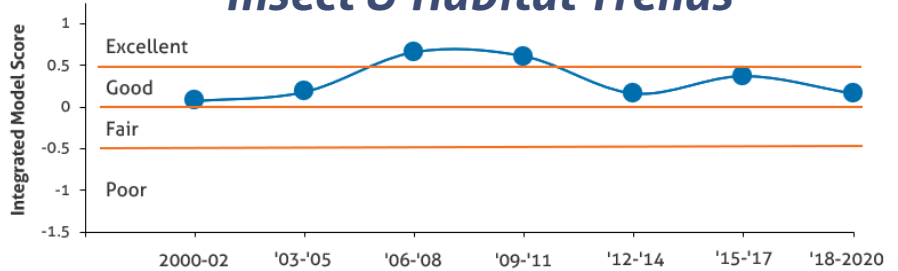
Insect & Habitat Trends

2000 - 2009	2010 - 2019	2020 - 2030
Number of Site Visits	Fall	5	5	0
	Spring	7	8	0
	Winter	8	8	0
Average Insect Diversity		13.13	13.23	-
Average Sensitive Diversity		2.88	2.23	-
Average Winter Stonefly Families		1.75	1.88	-
Habitat	# of Surveys	2 (2001, 2007)	2 (2011, 2016)	0
	Summer Water T (F)	64.4 - 74.15 (2000)	62 - 75 (2010)	-
	Stream Width (ft)	9.42	10.80	-
	% Big Rocks	2.0	9.53	-
	% Rocks & Gravel	33	26.98	-
	% Sand	60.0	45.85	-
	% Muck	4.5	13.1	-
